*Conservation of*  
**THE EID MISKIY,  
MALE'**  
Republic of Maldives  
**2006**

# Project Report

# **Conservation of *Eid Miskiiy Male'*, Republic of Maldives**

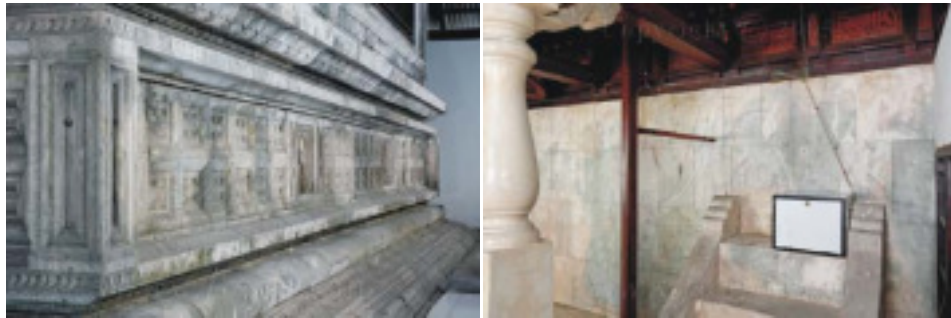
Coral stone was profusely infested with algal growth. The outer sides of walls all around had very thick growth, which, at places, appeared black and had covered the carvings completely. Even the inner side of the walls were also affected by algal growth.

The Coral stone being highly porous and pore diameter being moderately large, the algae had penetrated deep inside the pores, which appeared unsightly. Moreover, the organic acids liberated by the biological growths were further damaging the coral stone.

Though no living insect activity was observed, *Termicide* solution mixed with 2% solution of Pentachlorophenol in ethanol was used for dis-infection and eradication of insect and fungus activity on wood. Spray of 1% aqueous solution of Benzalkoniumchloride was used for the dis-infection and eradication of algal growth on coral stone.

Removal of algae from the coral surface was not a serious problem, but the algae that had penetrated inside the pores, was posing difficulty in its removal. The algae present inside the pores were removed using a jet of water at a suitable pressure. The water pressure of 4 kg/cm<sup>2</sup> was enough to clean the surface in most cases. To see the effect of water jet on the surface of the stone, NRLC while working for the conservation of Hukuru Miskiiy of Fenfushi Island, carried out the surface roughness studies on coral stone samples before and after the cleaning with water jet, and it was observed that there was no measurable erosion of the coral stone surface at the above mention water pressure, used for short durations just sufficient to clean the surface.

To prevent algal growth on coral, 1-2-ppm aqueous solution of *Ziram* was sprayed on coral stones.

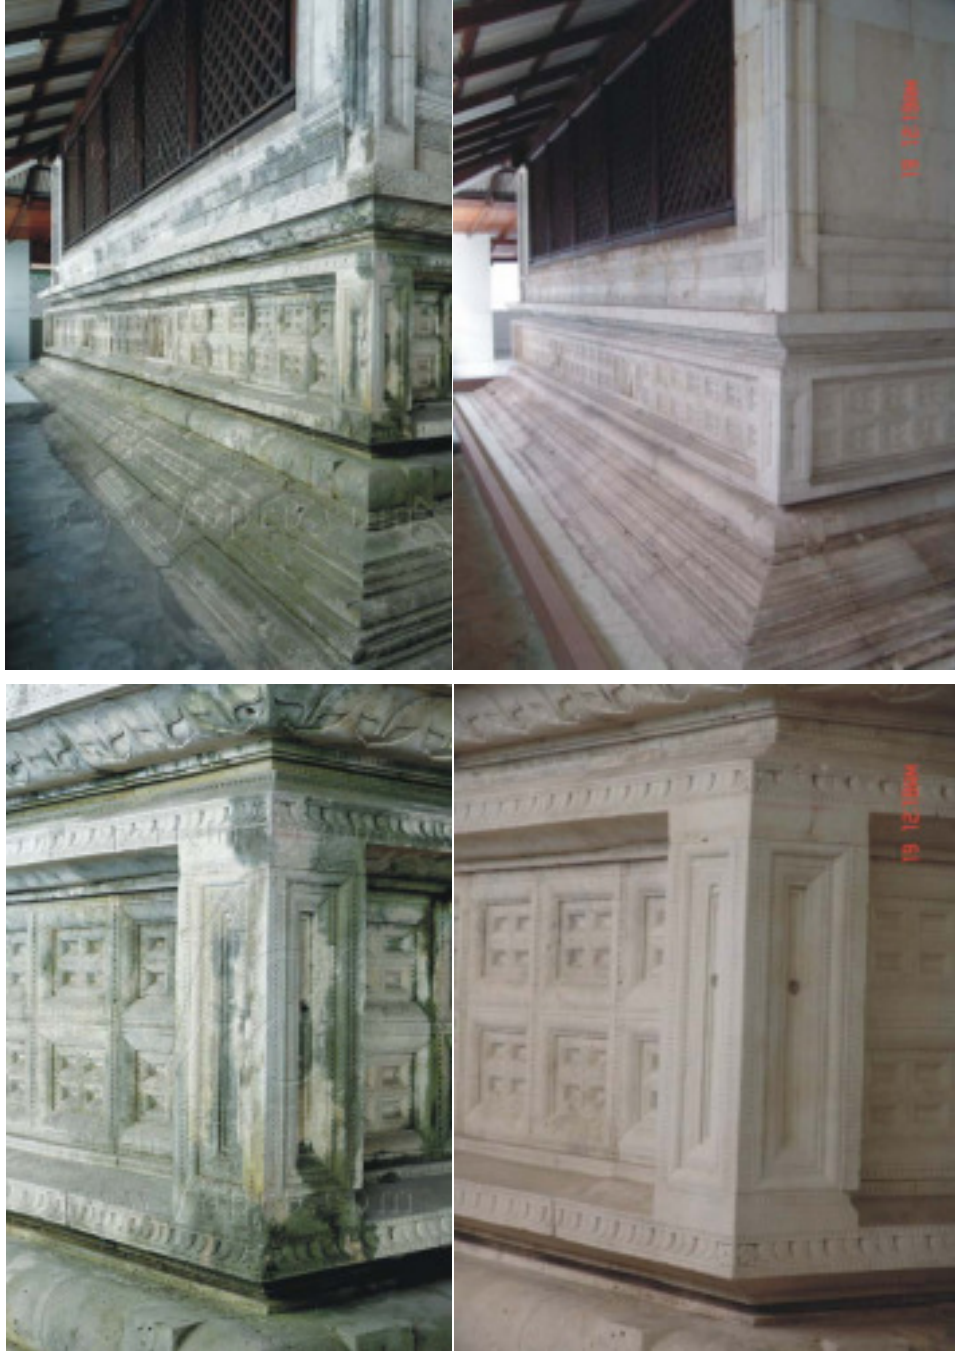
The monument got conserved to the fullest satisfaction of the conservators, which can be roughly assessed from the picture of the mosque before and after conservation. Cleaning and development of the surroundings along with interior decoration of the floor, will further improve the appearance of the mosque.
