*Conservation of*  
**THE EID MISKIY,  
MALE'**  
Republic of Maldives  
**2006**

# Project Report

# **Conservation of *Eid Miskiiy Male'*, Republic of Maldives**

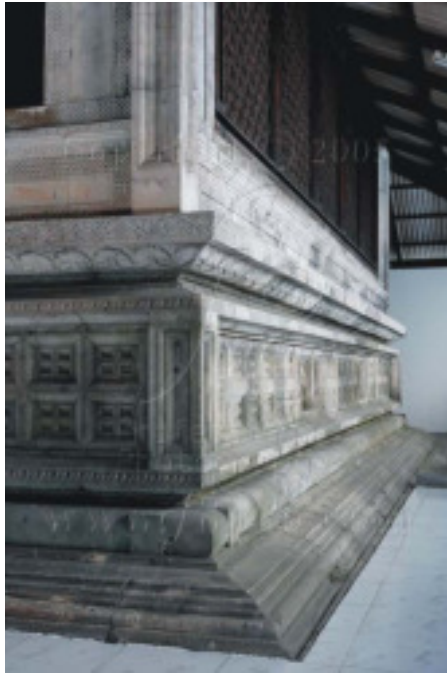
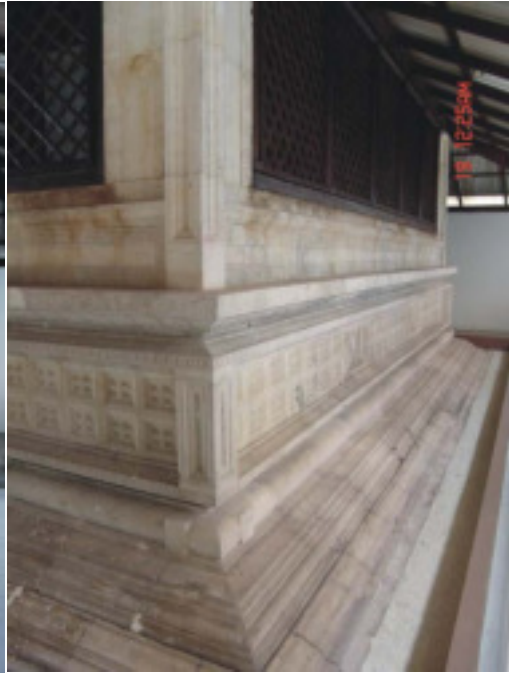
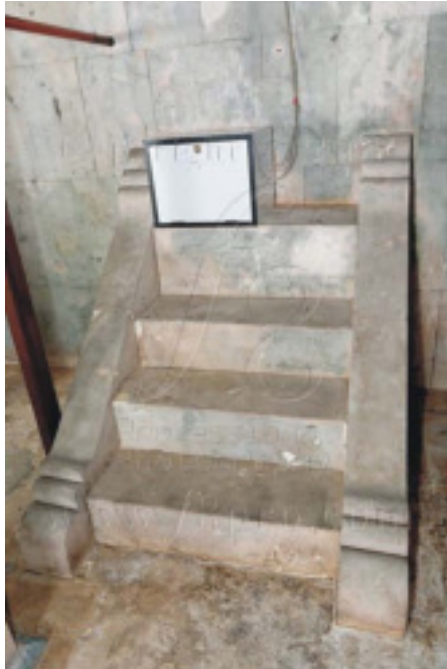
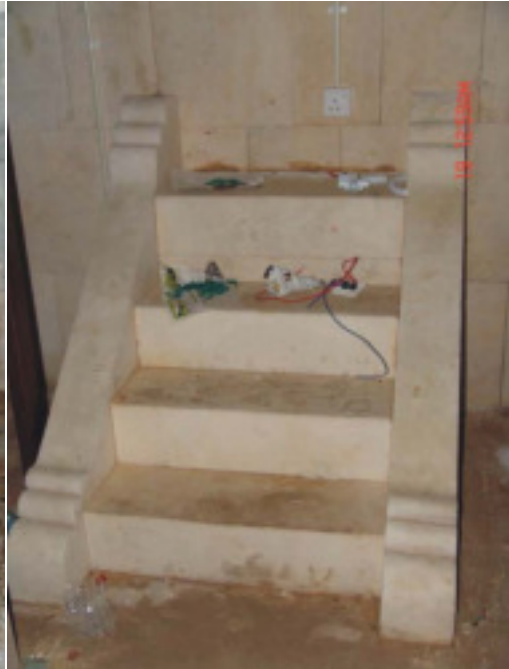
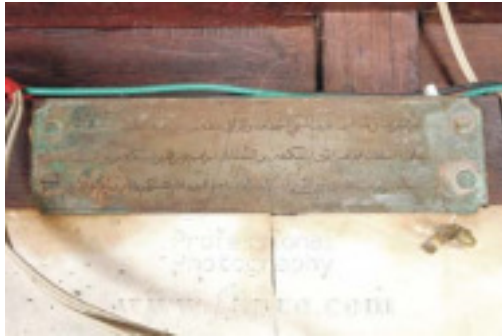
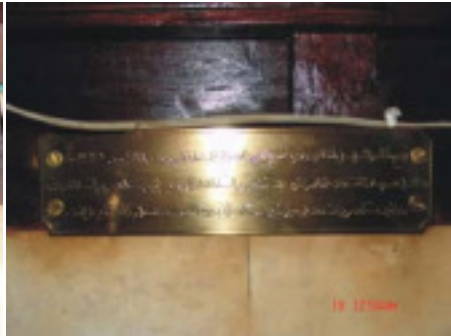
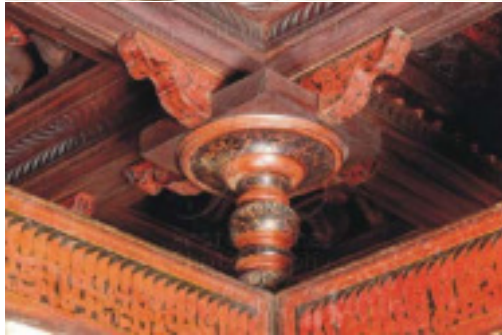
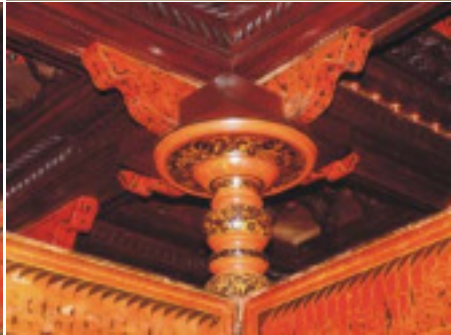
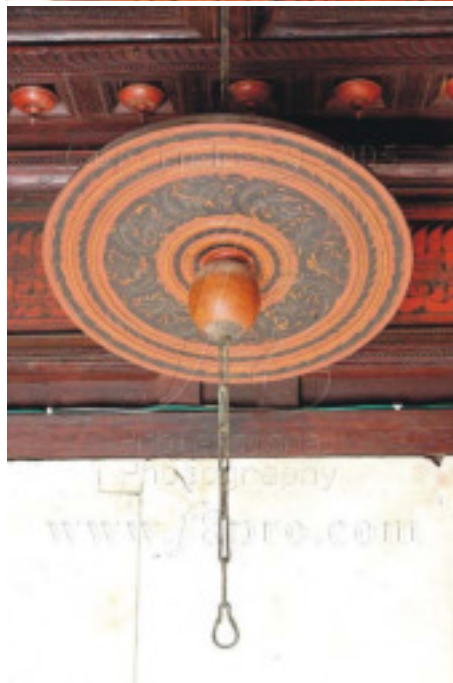
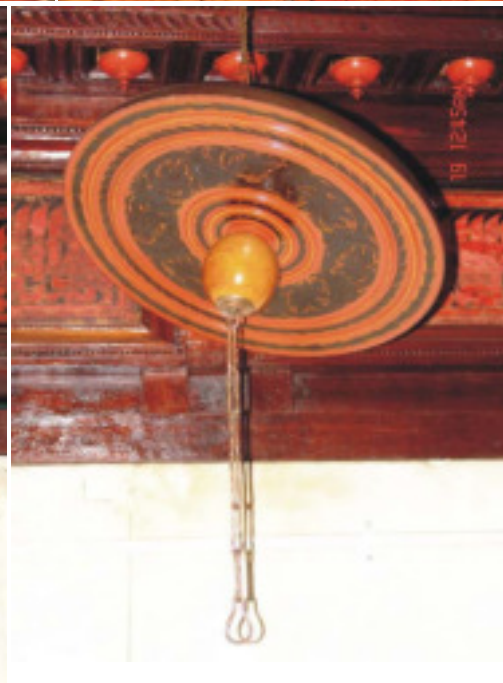
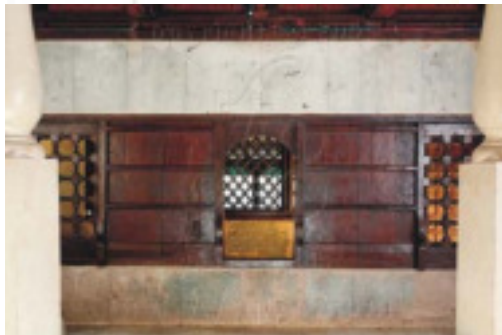
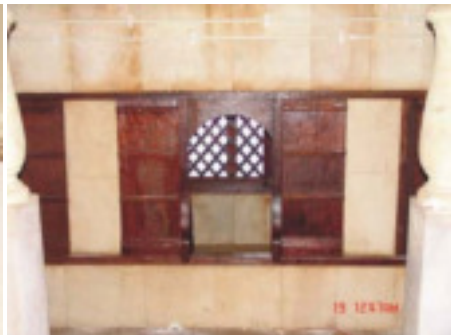
## 6. PRESENT CONDITION OF THE MONUMENT

The monument got conserved to the fullest satisfaction of the conservators, which can be roughly assessed from the picture of the mosque before and after conservation. Cleaning and development of the surroundings along with interior decoration of the floor, will further improve the appearance of the mosque.
